Geoenvironmental Appraisal

Land at Royal Victoria Court, Mendalgief Rd, Newport, south Wales

For LNT Care Developments

Report no: 5088/1

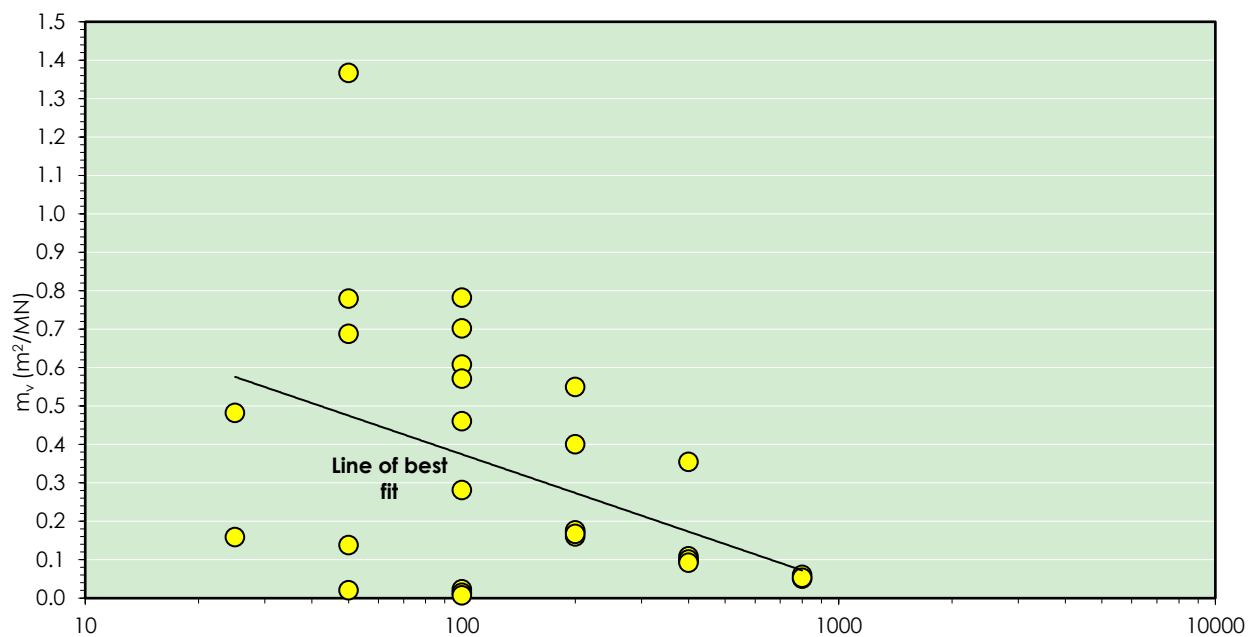
13.5.4 The graph below shows variation in m_v with depth (increasing overburden pressure; as plotted on a log scale).

**Maximum Volume Change Potential (M_v) Vs Overburden Pressure
 (Cohesive Tidal Flat Deposits- All)**

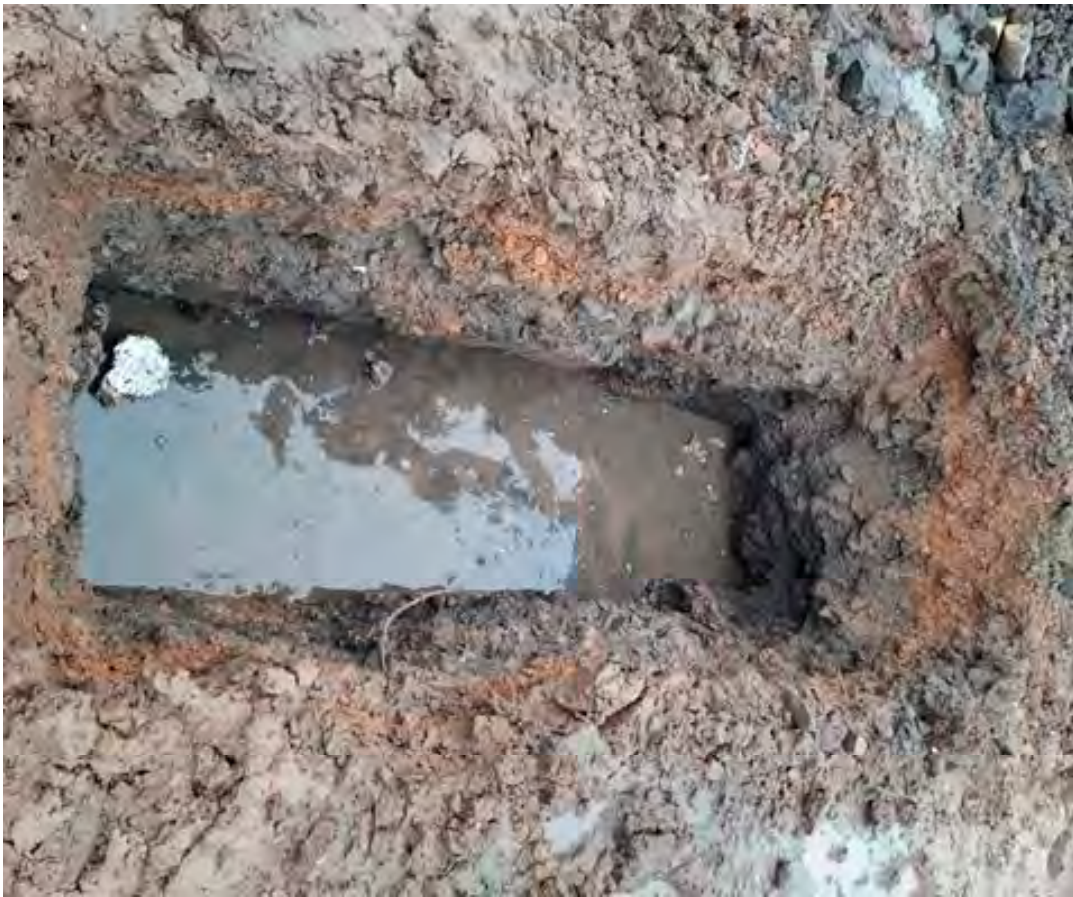
Trial Pit TP01 – Pit and groundwater level

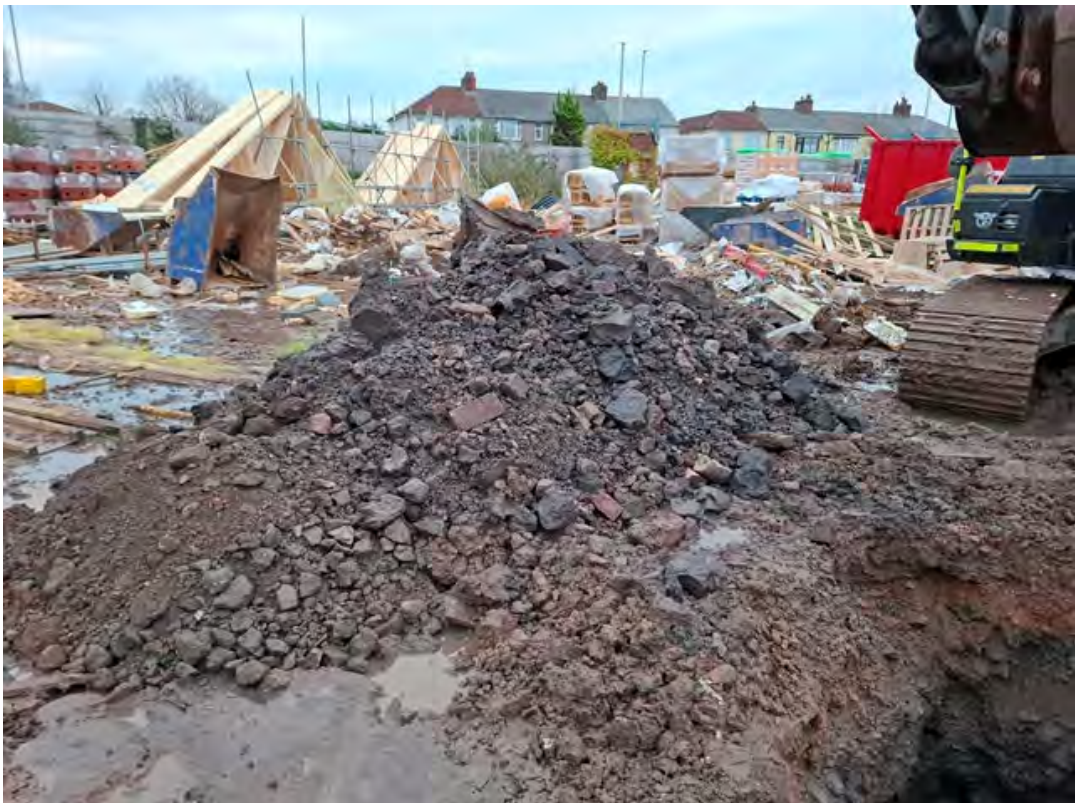
Trial Pit TP01 – Made Ground arising

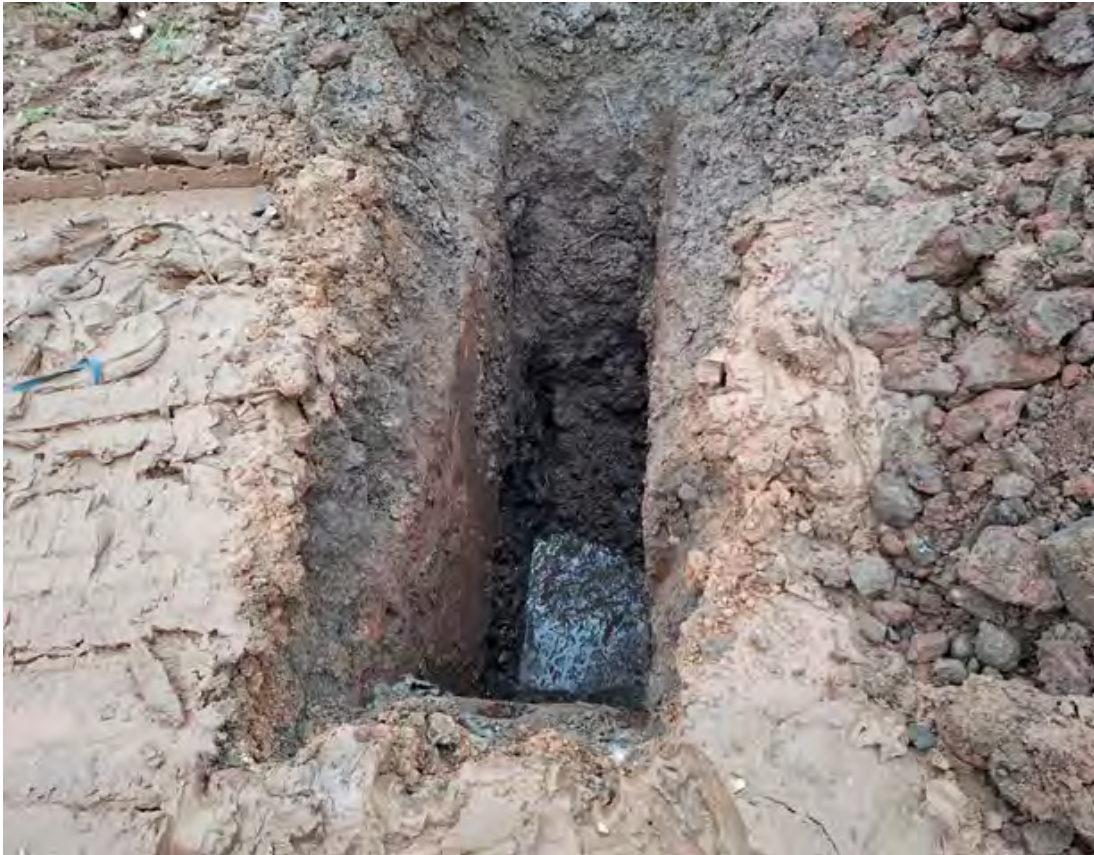
Trial Pit TP03 - Excavation

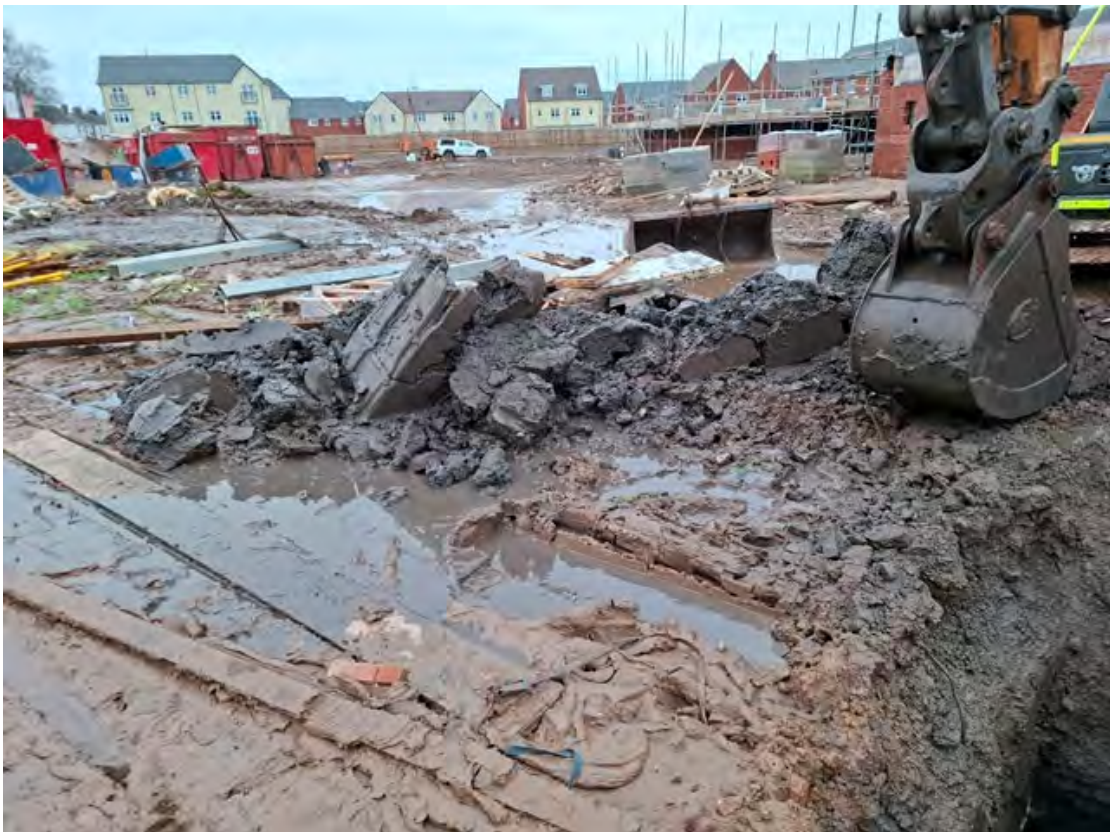
Trial Pit TP06 – Natural Ground arisings

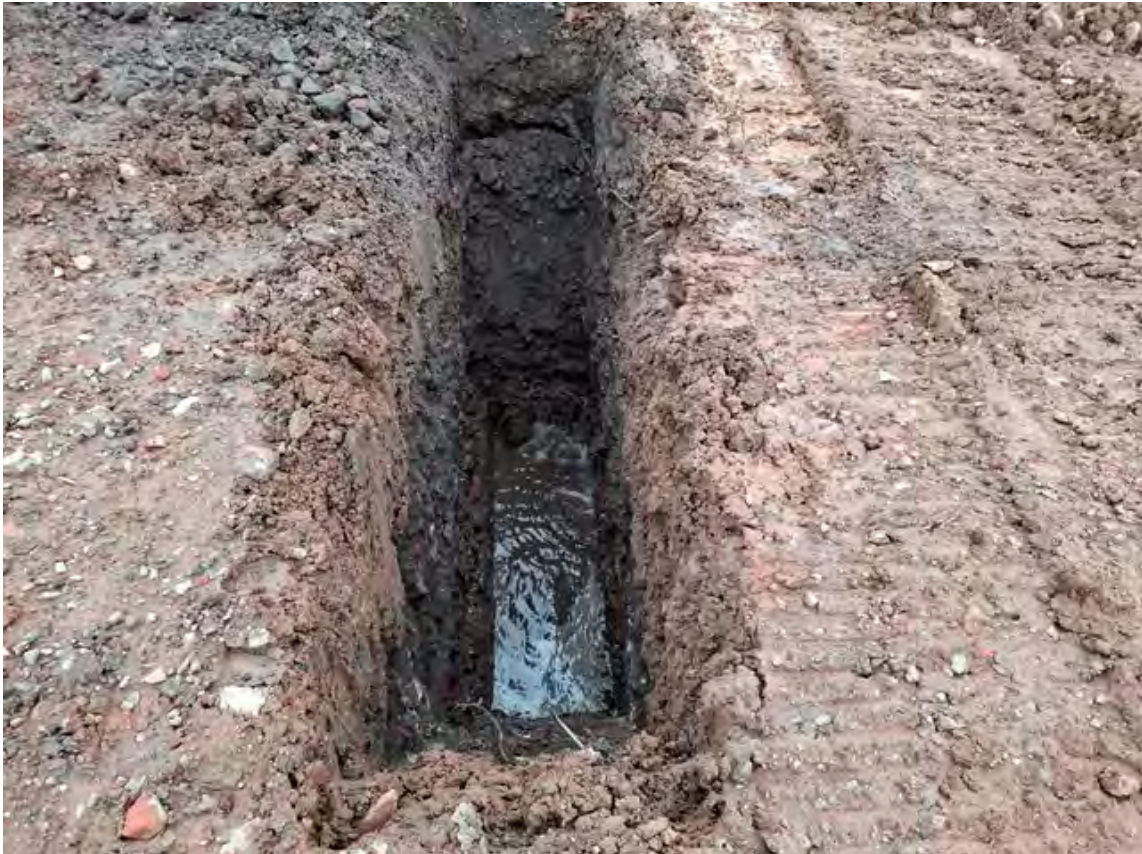
Trial Pit TP05 - Excavation

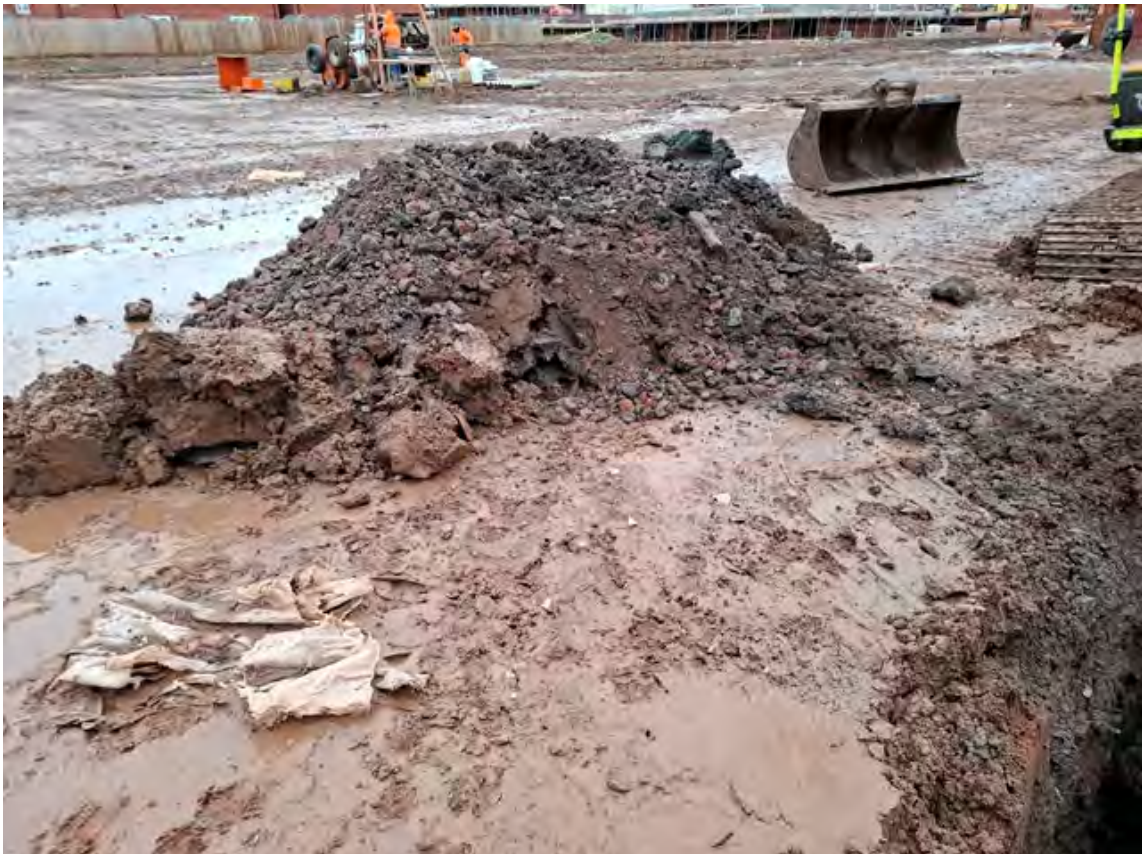
Trial Pit TP05 – Made Ground arisings

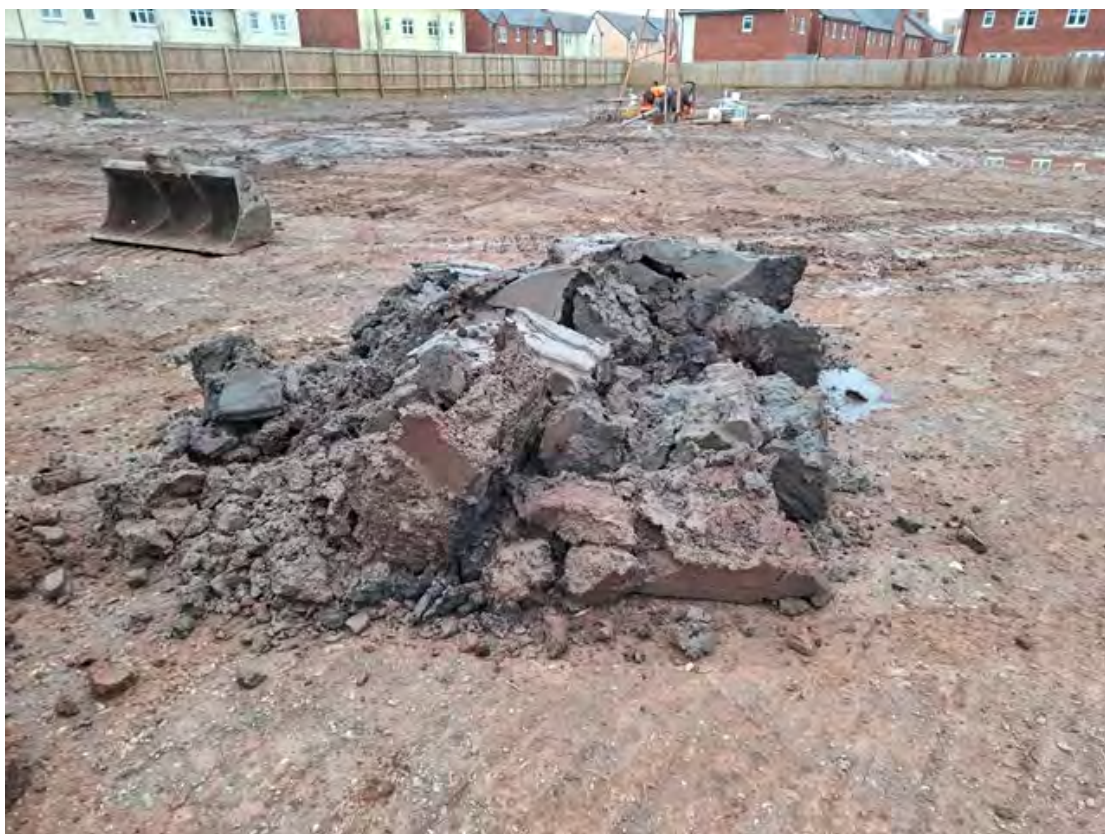
Trial Pit TP08 – Natural Ground arisings

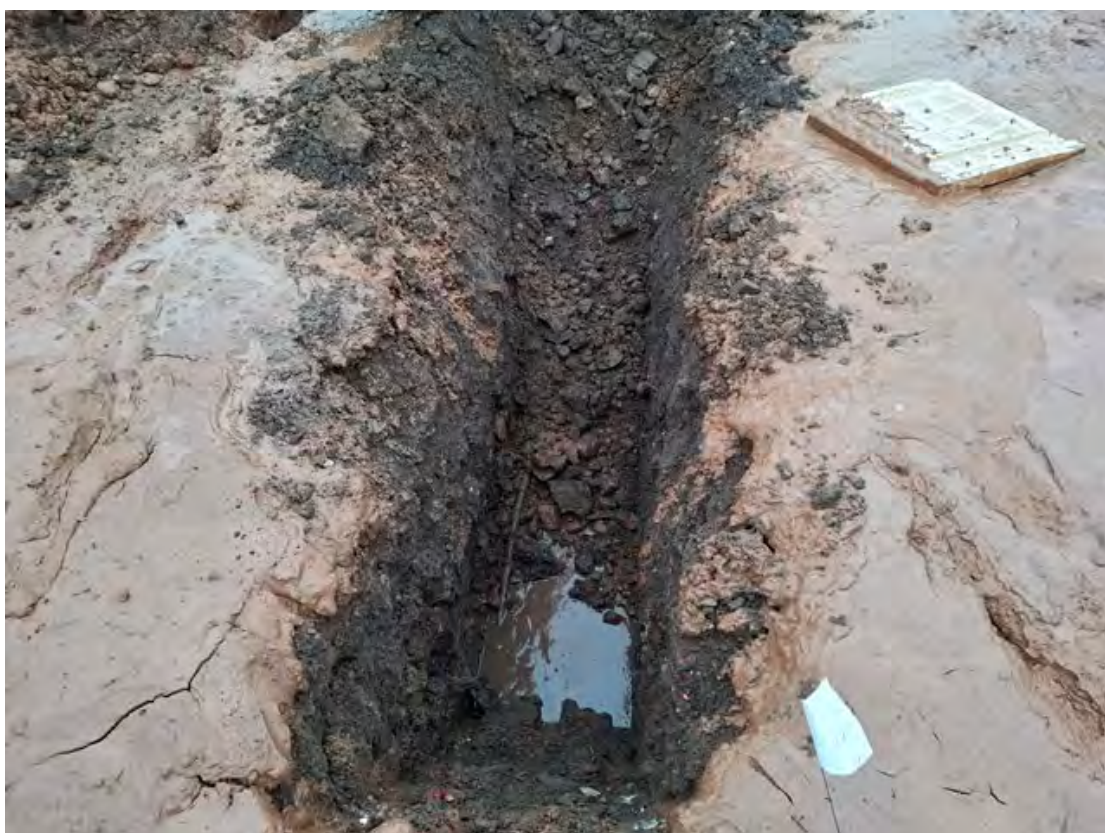
Trial Pit TP09 – Excavation
